ASSET MANAGEMENT INVENTORY AND DATA COLLECTION

Final Report

Submitted to the North Carolina Department of Transportation

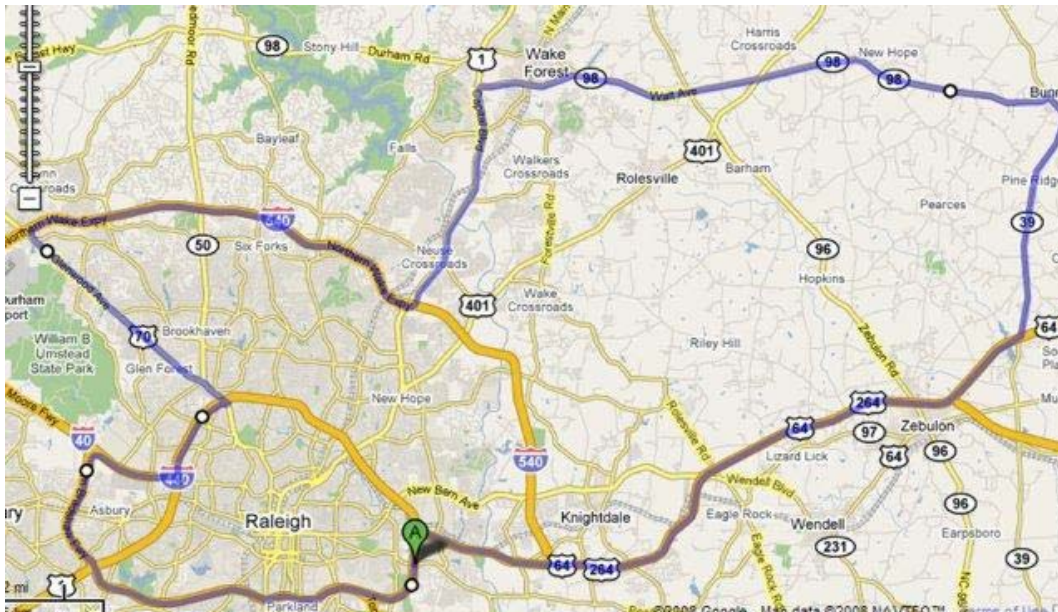
Figure 2.1. 90-mile test road located in central North Carolina.

The test road employed for this effort was a one-way (clockwise) 90-mile loop beginning and ending in Raleigh, NC. Figure 2.1 shows the road from the starting and ending point at the Poole Road and I-440 interchange (labeled as 'A' in Figure 2.1).

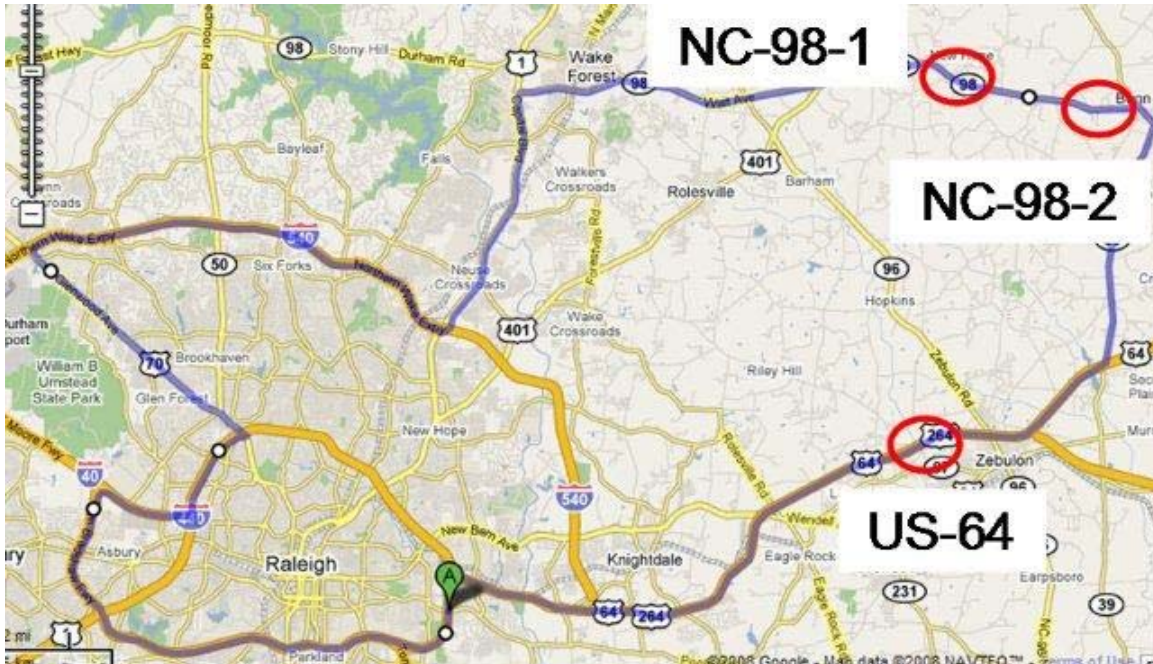
Figure 3.98. Location of data resubmission sections

All three sections are asphalt concrete and no resurvey by NCDOT personnel has been performed. Coordination of the vendor and reference surveys was accomplished by first identifying the approximate location of the beginning of the NCDOT survey using mapping software. The vendor submitted coordinates for their analysis sections were overlaid on top of this map and identified. The vendors were not explicitly told which NCDOT reference survey mile-marker their resubmission would be compared to. However, from the workshop the vendors did have available to them the results from the reference LTPP survey. Vendors were given explicit directions and data submission templates for the resubmission. The exact instruction letter sent to the vendors is given in Appendix D. For consistency with what has been presented above, the sections are denoted as NC-98-1, NC-98-2 and US-64 for LTPP survey purposes. For the NCDOT survey, the mile containing the first LTPP section corresponds to mile 11 along NC-

98 and is thus denoted as NC-98-11 for NCDOT survey comparisons. The second LTPP section is contained within the 15th mile of the NC-98 component and is denoted as NC-98-15. Finally, the US-64 LTPP section is contained in the mile 5 of the US-64 survey and is therefore denoted as US-64-5.

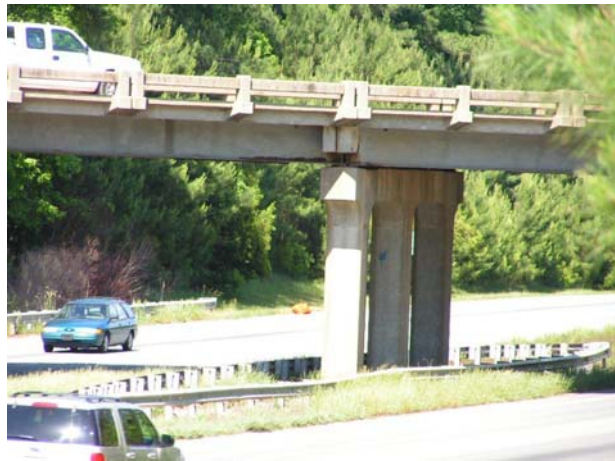
Figure 4.2. Bridge steel superstructure and CIP concrete pier substructure.

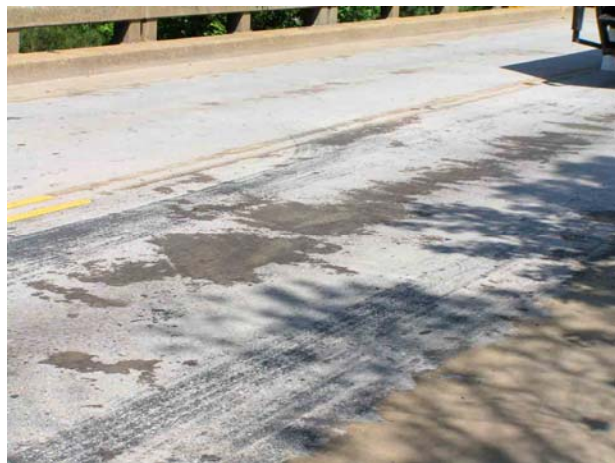
Figure 4.3. Patched concrete deck of bridge.

As advanced preparation, the NCDOT Bridge Management Unit collected additional data on the bridge condition, particularly the deck condition for possible comparison to vendor technology data. However, in the end, the participating vendors' collection data were limited to the collection of bridge geometry data which could be demonstrated on the test loop. Presentations during the workshop covered a broader range of bridge assessment topics.

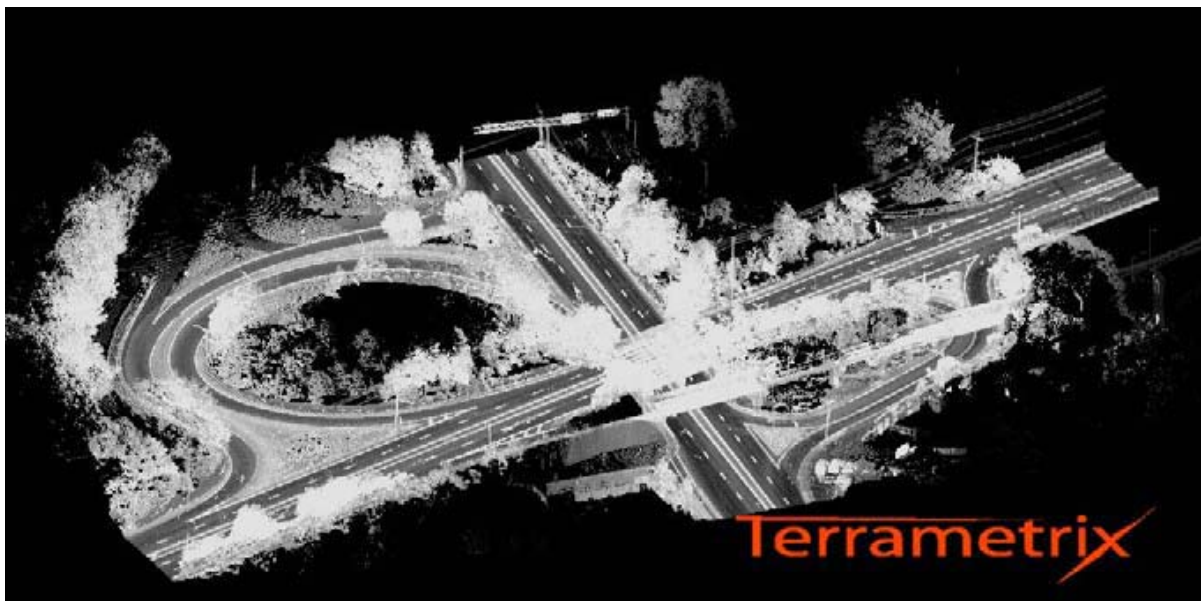
Mr. Frecks' company uses multiple 2D LIDAR (**L**ight **D**etection **A**nd **R**anging) systems mounted on a vehicle to produce 3D surveys that are dimensionally accurate. These surveys are conducted mainly on established roads and normally extend well beyond the limits of the road. Mr. Frecks described the method behind the data collection and explained that a survey of several miles can be conducted in a matter of days as opposed to weeks or months and much more information can be extracted from the resulting file. Mr. Frecks provided several 'fly overs' as an example of what can be done with the data as shown in Figure 4.4. The main interest in the data at the present is the ability to determine bridge height clearances based on the data that is collected. The file also integrates GPS data to accurately identify locations in GPS coordinates. Because this technology provides essentially the existing 'surface,' the bridge under deck can be analyzed and clearances taken at varying intervals. Mr. Frecks explained that there exists immense ability to extract whatever geospatial data may be needed from within the resulting survey files.

Figure 4.4. View resulting from dynamic multi-directional scanning

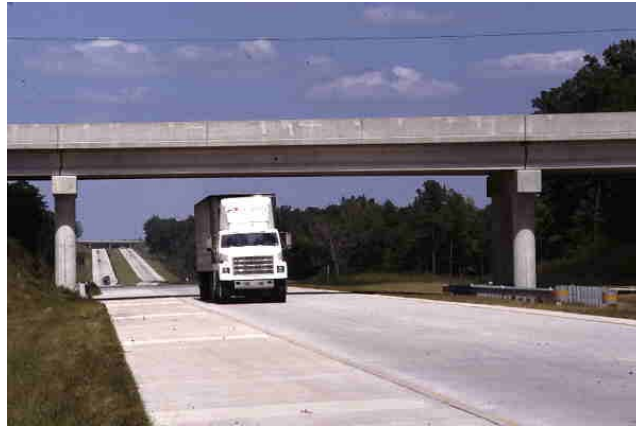
Figure 4.5. Bridge vertical clearance at grade separations.

The bridge inventory contains bridge vertical clearance data for both the roadway served and the under-roadway at grade separations. Ideally, the vertical clearance is adequate with a margin of safety for passage of vehicles up to the legal limit of 13 feet and 6 inches as shown in Figure 4.5. Posting of the clearance is generally provided when less than 14 feet and 6 inches. Even when the clearance is greater than the legal limit, vehicles or loads exceeding the limit can cause damage to the bridge as shown in Figure 4.6 and Figure 4.7.

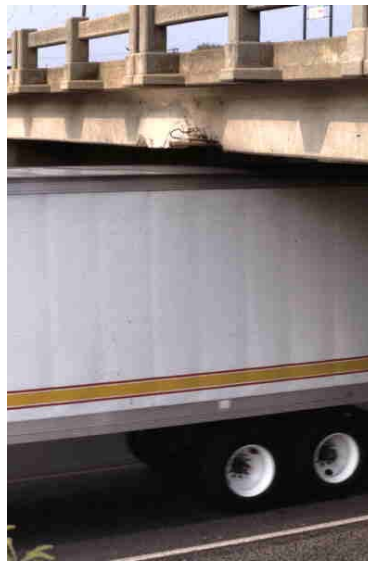
Figure 4.6. Vertical clearance for vehicles at grade separations.

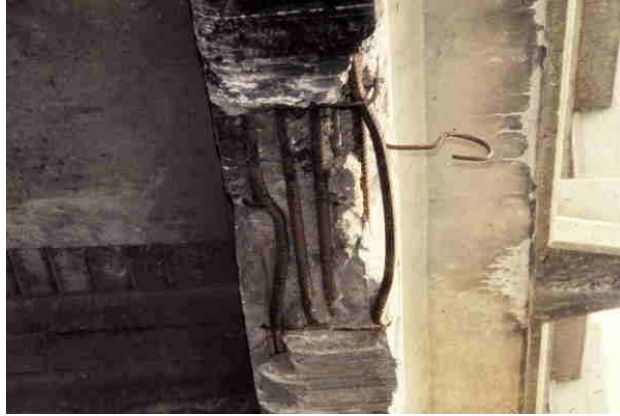
Figure 4.7. Bridge damage due to vertical clearance deficiency collisions.

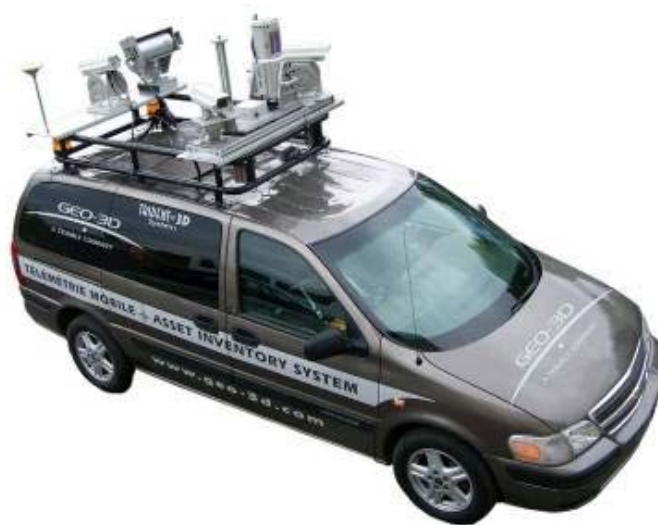
Figure 4.8. Geo-3D mobile data collection vehicle.

Two vendors participated in the test track data collection effort, Geo-3D and Terramatrix. Each provided vertical clearance data for a select number of bridges. The types of mobile data collection vehicles used are shown in Figure 4.8 and Figure 4.9. Each employs LIDAR for the survey process. After the basic field collection of position data, the data is reduced through extensive analysis to produce the required geometric results.

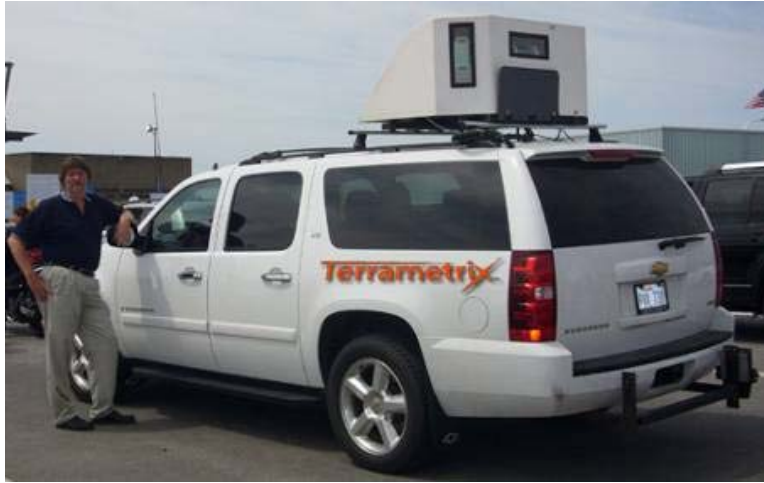
Figure 4.9. Terrametry mobile data collection vehicle.

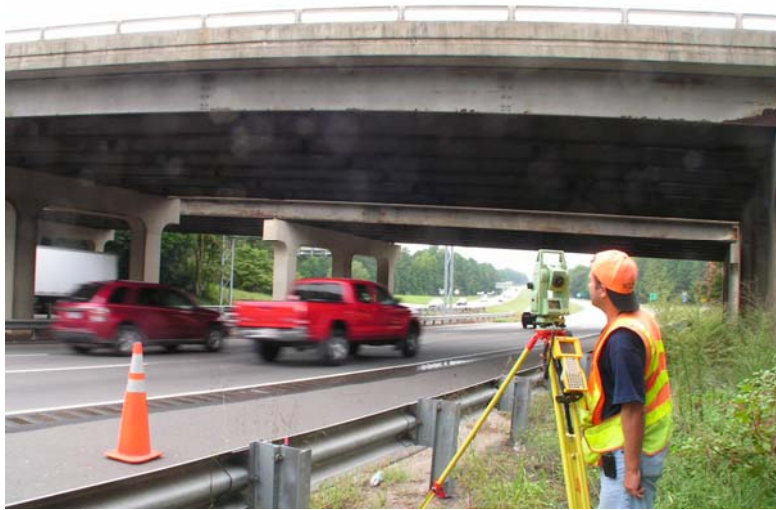
Figure 4.11. NCDOT special survey of vertical clearance at selected bridges.

Reference survey data was gathered by the NCDOT. These personnel surveyed vertical clearances at the lane lines for the first and last girders of several bridges using a stationary LIDAR instrument as shown in Figure 4.11. In addition, existing data in the bridge inventory file was reviewed for comparison.

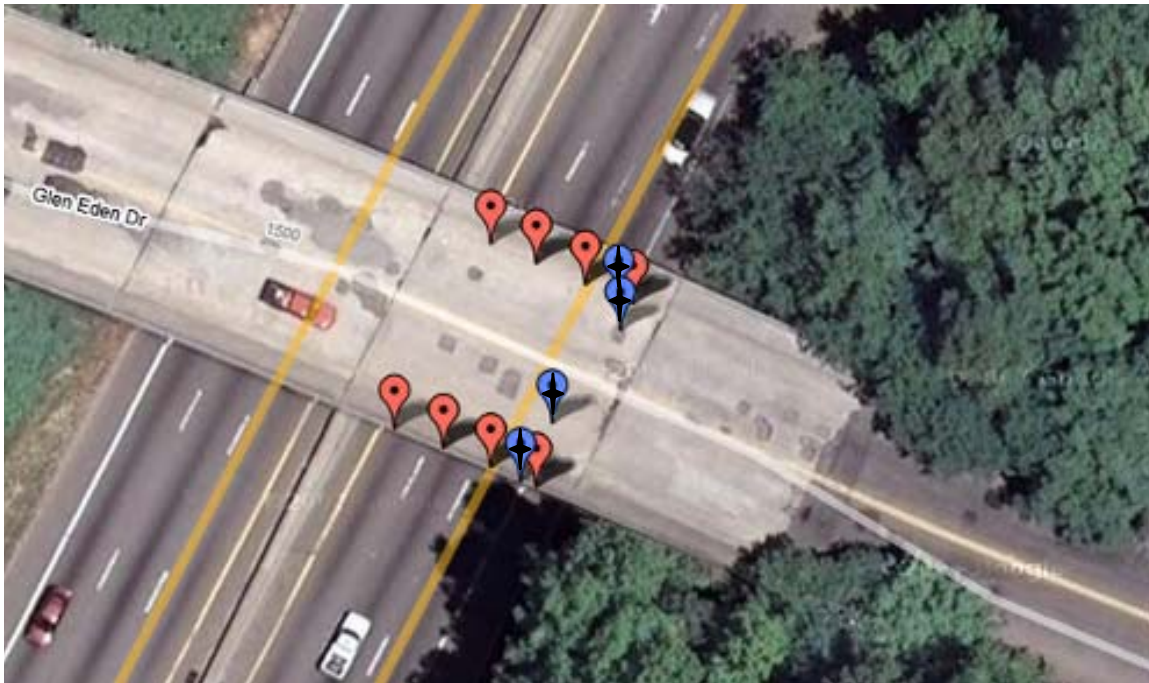
Figure 4.13. Survey and Geo-3D measurement locations for Glen Eden Drive bridge.

Table 4.2 lists the vertical clearance data from several sources for the Glen Eden Drive bridge over the north-bound lanes of I-440 in Raleigh, NC. Figure 4.13 and Figure 4.14 show the locations of the specific data points in plan plotted using the point longitudes and latitudes in Google Maps satellite view. The patterns of data collection from the NCDOT survey (first and last girder over lane markings), from Geo-3D (each girder along a single path) and from Terramatrix (first and last girder generally over three lane markings) are visible in Figure 4.13 and Figure 4.14. The presentation of the data in Table 4.2 is in a similar pattern to facilitate comparison. In general, there is a significant agreement among the data sources within one or two inches of variation.

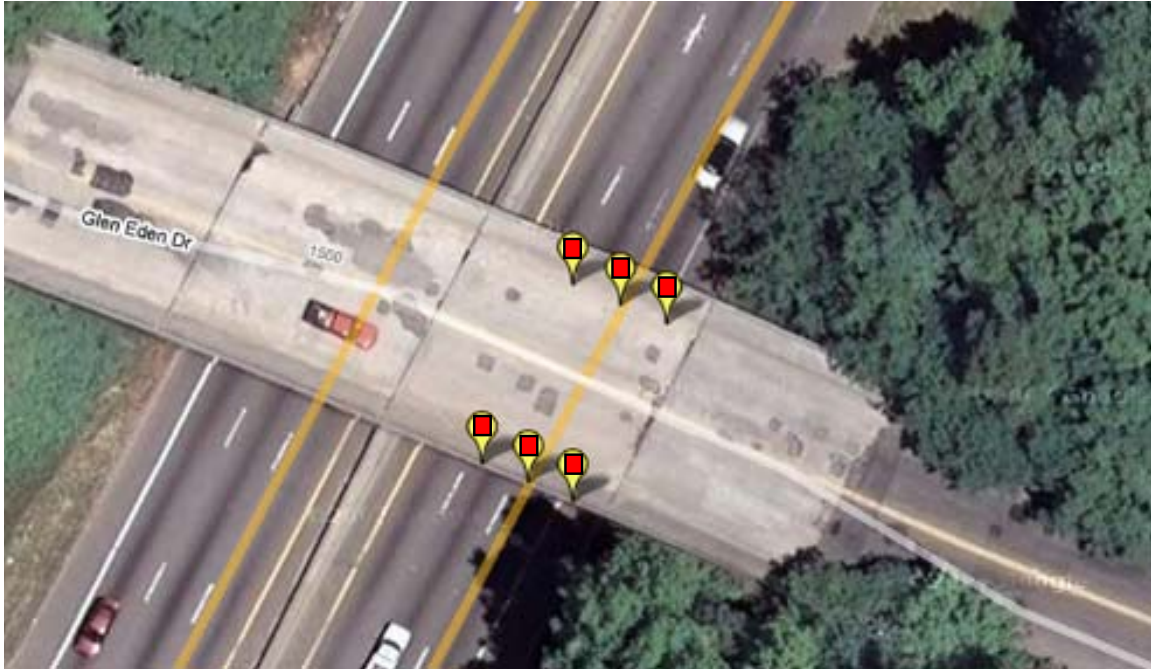
Figure 4.14. Terramatrix measurement locations for Glen Eden Drive bridge.

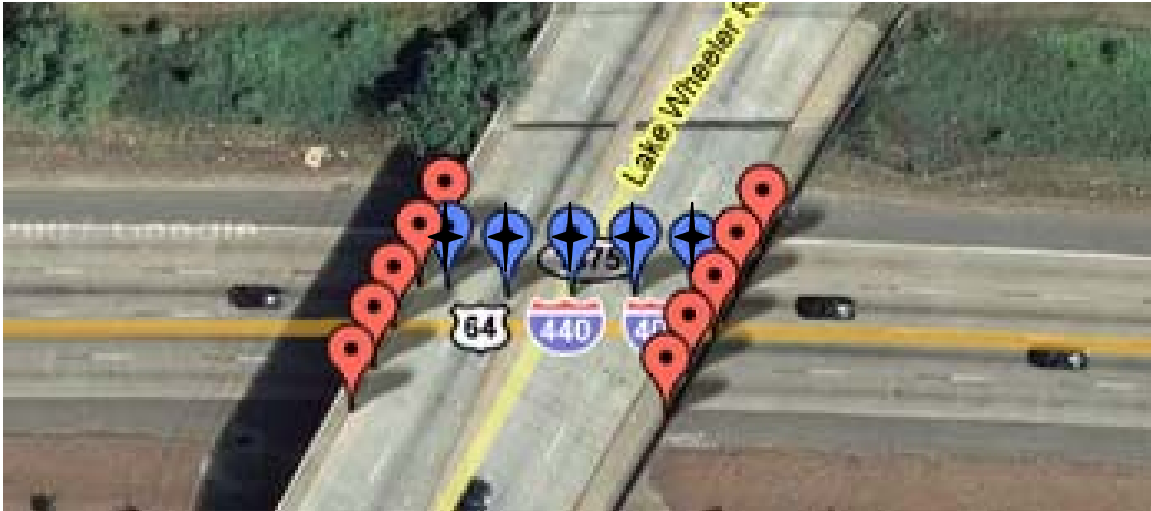
Figure 4.15. Survey and Geo-3D measurement locations for Lake Wheeler Road bridge.

Table 4.3 lists the vertical clearance data from several sources for the Lake Wheeler Road bridge over the west-bound lanes of I-440 in Raleigh, NC. Figure 4.15 and Figure 4.16 show the locations of the specific data points in plan. This bridge has a substantial skew and both the under roadway and the bridge deck have significant super-elevation variations. It should be noted that the inspection report clearances are for the first girder for Lane 1 but for the last girder for Lane 4 and an intermediate girder at the median marking. Thus, it can be interpreted that there is reasonable correspondence between the NCDOT survey data and the inspection report values. Some of the data collected in motion had reasonable agreement with the NCDOT survey values; however, in some other cases, the reduced clearances were off substantially. It is believed that the LIDAR scans in some cases may have been associated with the underside of the deck rather than the underside of the last girder.

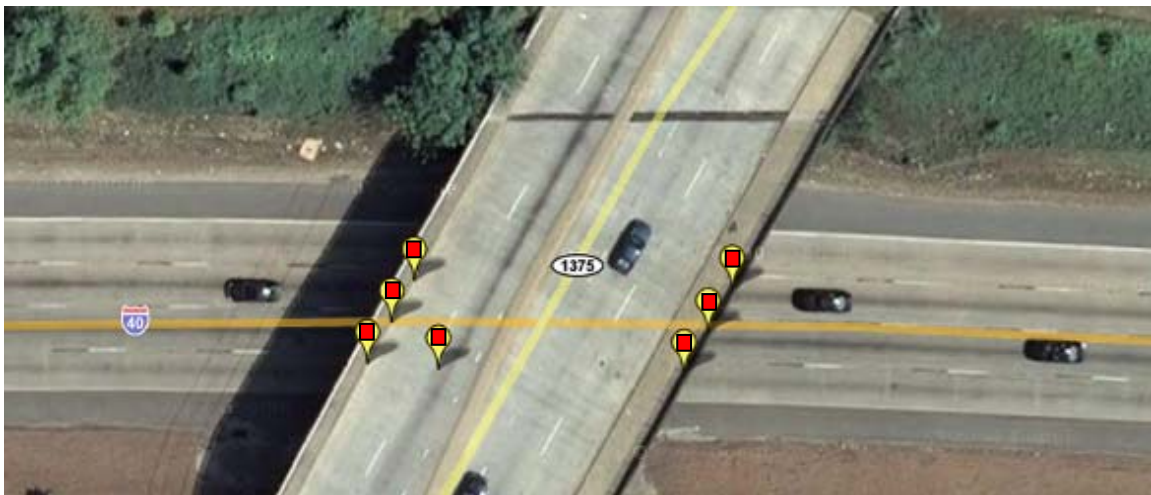
Figure 4.16. Terrametrix measurement locations for Lake Wheeler Road bridge.

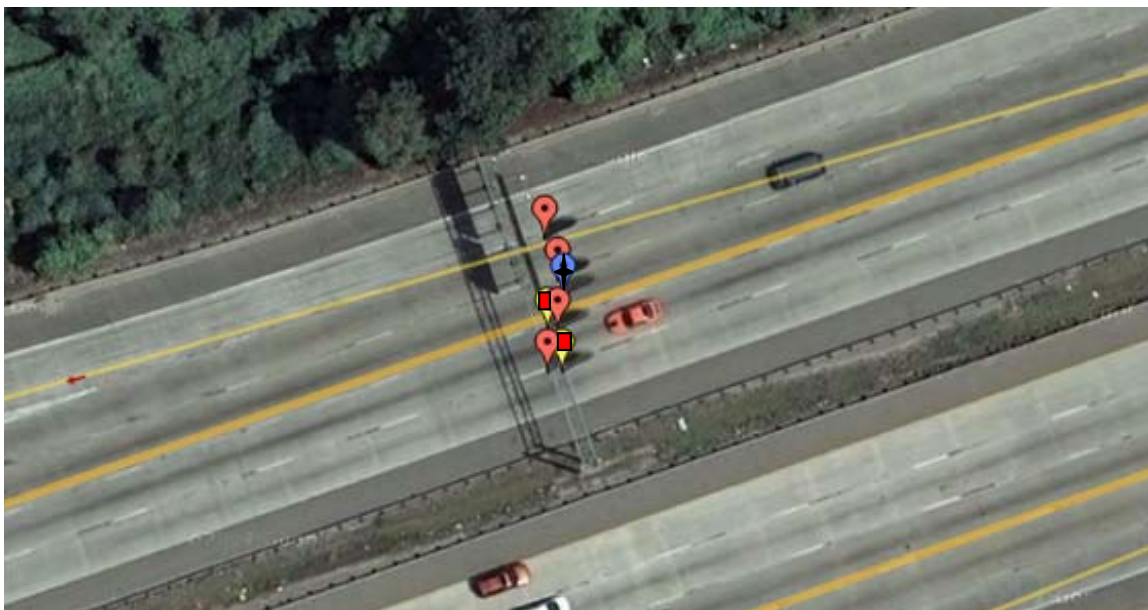
Figure 4.17. Measurement locations for South Saunders Street exit sign.

Table 4.4 lists the vertical clearance data from the various sources for the South Saunders Street exit sign over the west-bound lanes of I-440. Figure 4.17 shows the locations of the specific data points. This sign structure has two signs mounted over the rightmost lanes with lower clearance than exists for the leftmost lanes with the structure only above. The clearances are further complicated at the signs with lower brackets under the signs at specific points to support sign lighting fixtures. Thus, there can be variations between the clearances to the brackets and the clearances to the lower edge of the sign. Since the data was often collected for the path along the pavement marking, these locations may not correspond to the brackets lower clearances. Thus, the differences in the measurements based on the various sources and locations can be reasonably understood. The inventory listing for the maximum-minimum clearance reasonably corresponds to the in-motion data values submitted. Nevertheless, it is apparent that the capability to reduce the data and obtain the clearance at the brackets will be important at overhead signs.

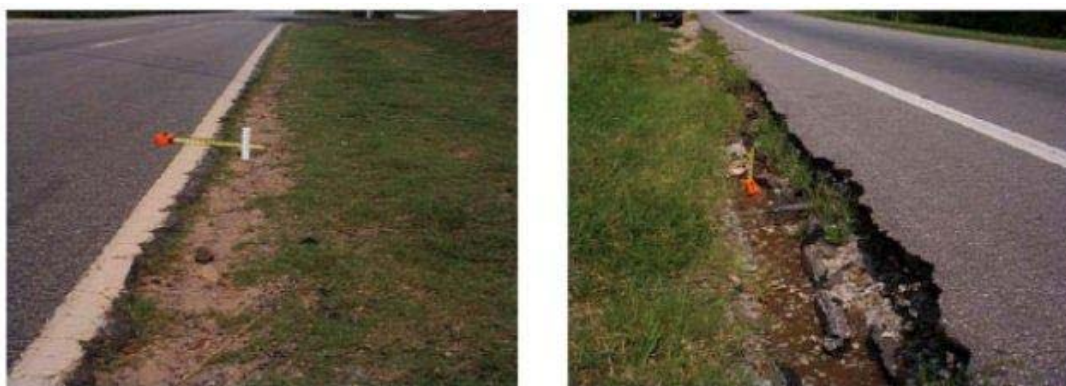
Feature Description: Low shoulders occur when the elevation of the unpaved shoulder is lower than the roadway edge of pavement. A low shoulder can result in an unsafe recovery in the event a vehicle leaves the roadway. A low shoulder can also hold water that may eventually penetrate the base and subgrade and weaken the roadway.

Threshold Condition: A low shoulder should be noted where the elevation difference is **2 inches** below the roadway edge of pavement, or lower.

Figure A.2. Low shoulders.

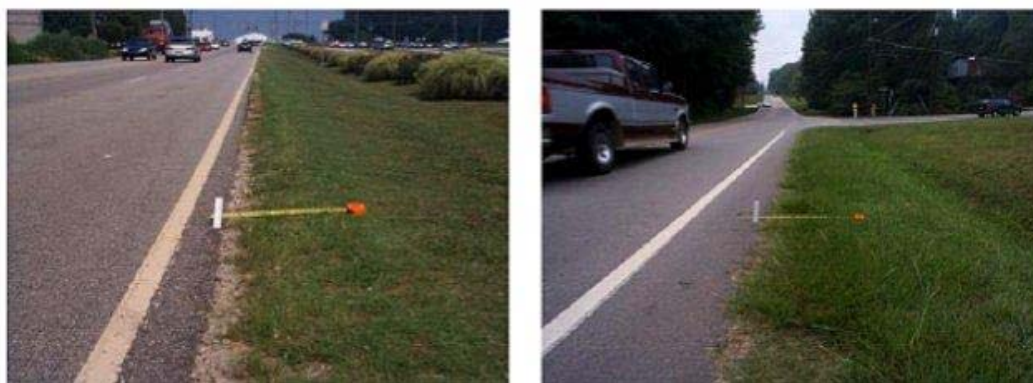
Feature Description: High shoulders occur when the elevation of the unpaved shoulder is higher than that of the roadway edge of pavement. A high shoulder can restrict water drainage and result in ponding at the edge of roadway. The standing water can cause vehicle hydroplaning, and may also infiltrate the base and subgrade and weaken the roadway. The relief of ponding caused by a high shoulder may also scour the shoulder and front slope.

Threshold Condition: A high shoulder should be noted where the elevation difference is **1 inch** above the road surface, or higher.

Figure A.3. High shoulders.

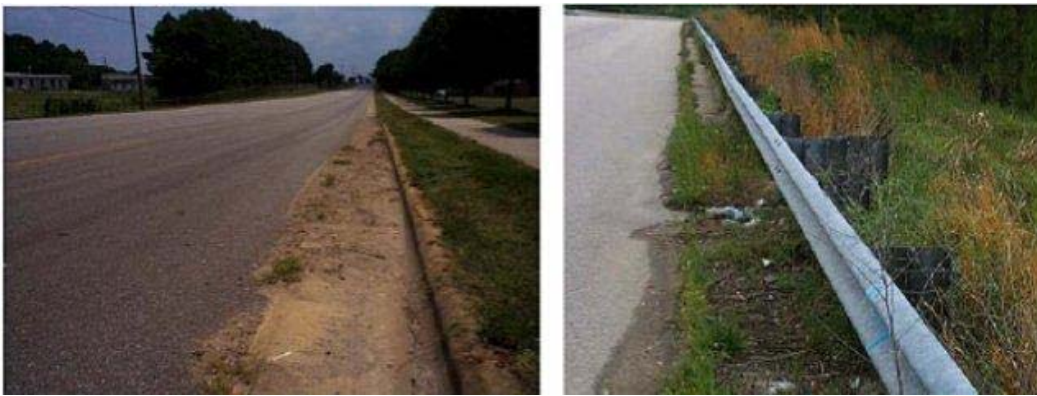
Threshold Condition: Gutters that are not functioning as designed due to an obstruction **2 inches or greater for at least 2 feet** of gutter length should be noted.

Special Instructions: Blockage will not be noted if it will not obstruct water flow (grass growing in a construction joint, trash that will be flushed clean in the next storm, etc.). At intersections, measure the gutter longitudinally through the intersection; do not measure around the corner radius. Short sections of monolithic barrier (e.g., 4-foot wide by 50-foot long concrete median island) will not be included in this inventory.

Figure A.4. Gutters blocked.

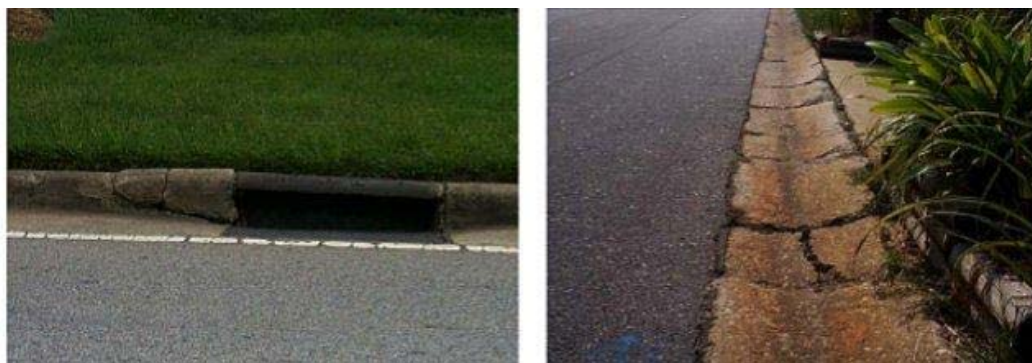
Feature Description: See feature description for Gutters Blocked. If the gutter is damaged, water can infiltrate the road base and weaken the roadway.

Threshold Condition: Any **damaged** gutter should be noted, such as cracking, settlement, misalignment, or deterioration.

Figure A.5. Gutters damaged.

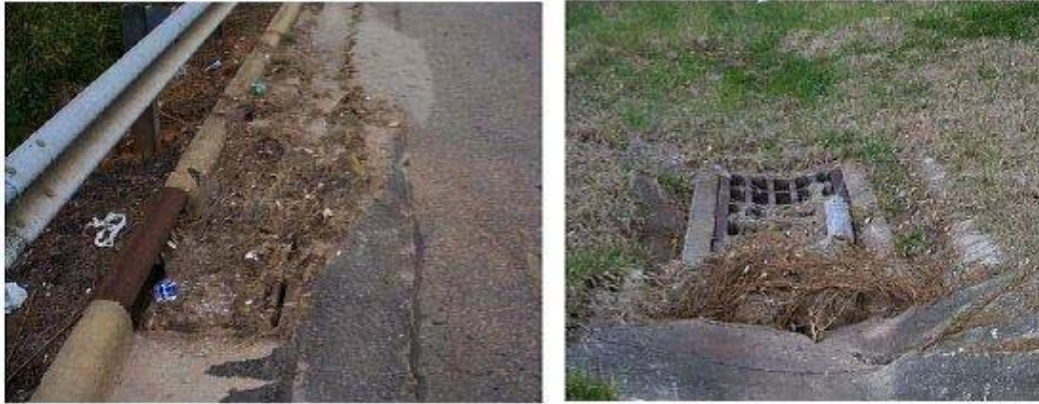
Feature Description: Inlets are the openings through which water enters an underground drainage network. They can be found in curbs, ditches, valley gutter, and at other locations that are designed to collect water runoff. Examples of inlets are catch basins, drop inlets, shoulder drains, and slope flumes. If the inlet is blocked, water ponding may occur at the obstructed opening. This can result in scour and erosion at an off-road structure, or vehicle hydroplaning if adjacent to the travelway.

Threshold Condition: Inlets that are **50% blocked** or more should be noted.

Figure A.6. Inlets blocked.

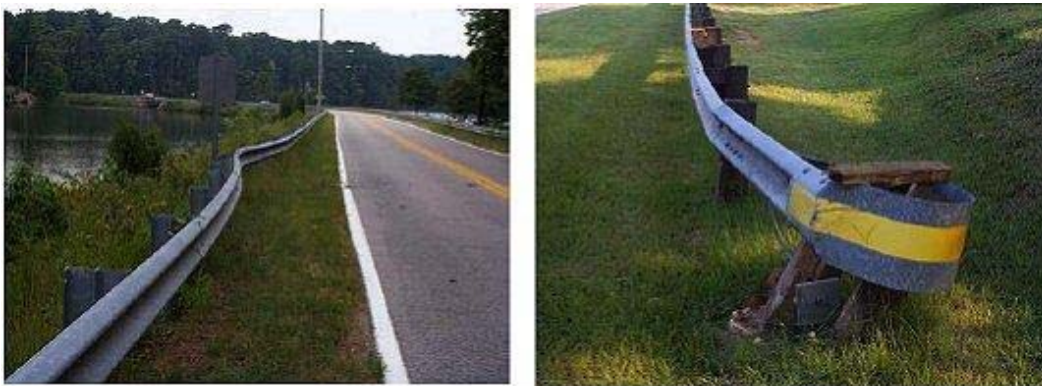
Threshold Condition: Barrier should be noted when it is **not functioning as designed** or has been **damaged**. Damaged barrier is defined as follows:

- W-beam guardrail – the rail beam is crushed more than 18 inches out of line, if the rail has been severed, or if three or more posts have been broken,
- Cable rail – if any cable is broken, if the cable is sagging to the point that it would not function properly, or if four or more posts have been knocked down, and
- Concrete barrier – if it has been damaged such that it would not function properly.

Figure A.7. Damaged barriers.
