NCHRP Project 03-78b

FINAL
Guidebook for the Application of Crossing Solutions
at Roundabouts and Channelized Turn Lanes for
Pedestrians with Vision Disabilities

NCHRP 3-78b -
Guidelines for the Application of Crossing Solutions
at Roundabouts and Channelized Turn Lanes for
Pedestrians with Vision Disabilities

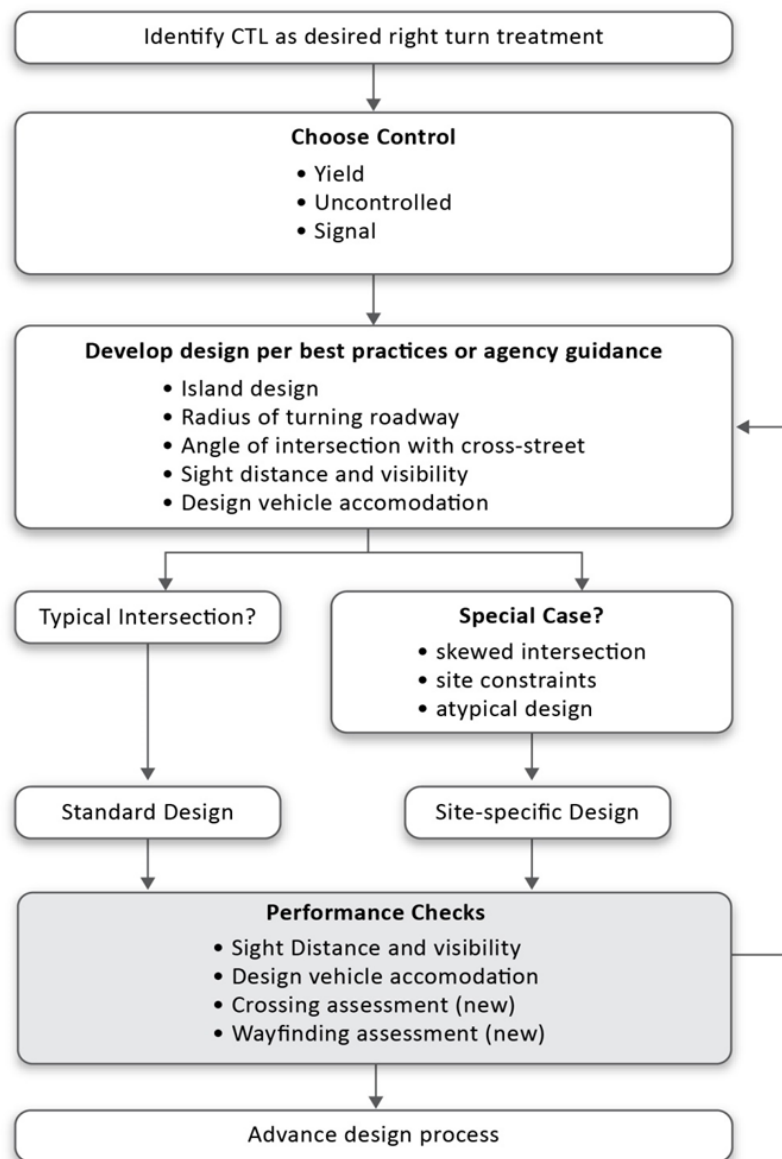
Figure 2-2: Channelized Turn Lane Design Process

The key aspects of this figure are selection of control and design development per established practices. Operational needs, land use and contextual environment, and agency preferences are all factors influencing the selection of control. The AASHTO Green Book, agency guidance documents, and typical detail drawings are factors influencing the selection of island size, turning roadway width and radius, and crosswalk location, to name a few of the elements of CTLs. In some cases, site-specific conditions necessitate variations of established practices. For example, if an intersection is skewed, the turning roadway width and radius required to accommodate a design vehicle may need to be determined with vehicle turning template software rather than the orthogonal intersection figures in the AASHTO Green Book.

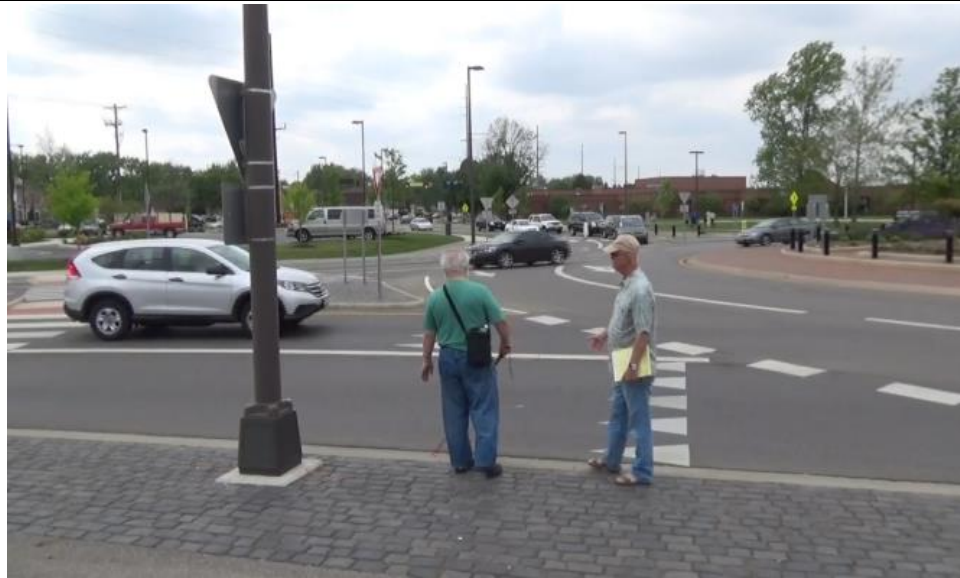
Figure 3-1: Image of Pedestrian Initiating Crossing from a Point Outside the Crosswalk and towards a Roundabout Circulatory Roadway

The image shows a blind pedestrian lined up to cross towards the roundabout circulatory roadway during research trials. At this location, there is a cobblestone type surface between the sidewalk and roadway, which was not recognized as a non-walking surface by blind participants in research. An O&M specialist is standing nearby. The crosswalk is visible to approximately 20 feet to left of the pedestrian in the photo

If pedestrians who are blind use the strategy of crossing from where they first arrive at the curb at roundabouts without appropriate treatments, they are likely to cross into the circulatory roadway (see photo in Figure 3-1). At CTLs, this strategy may result in a crossing at a location that is not within the crosswalk, missing the island entirely, or encountering landscaping at the end of the crossing that makes it very difficult to get out of the lane.

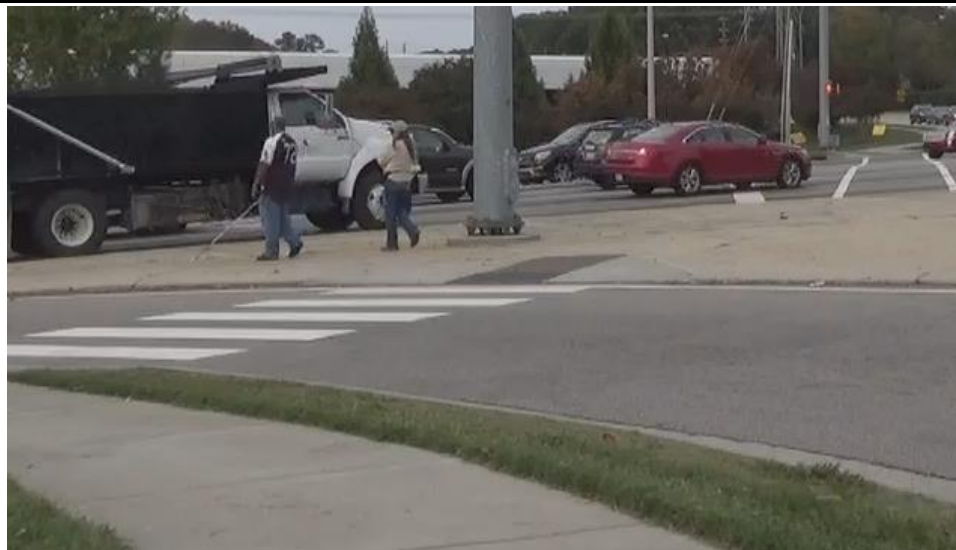
Figure 3-2: Image of pedestrian in research disoriented on a large paved CTL island

This image shows a pedestrian in research disoriented on a large paved CTL island, walking away from the crosswalk; an orientation and mobility specialist follows nearby.

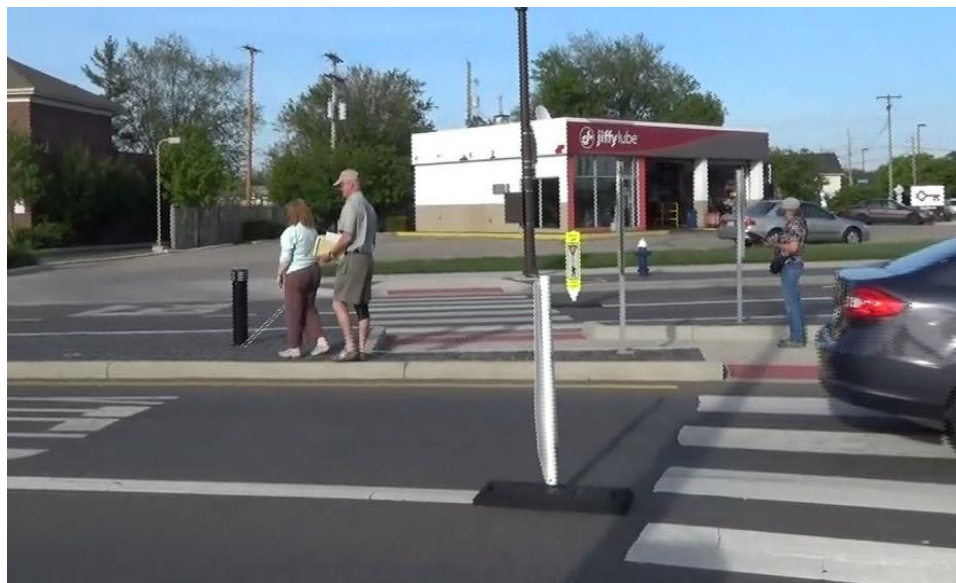
Figure 3-3: Pedestrian walking on splitter island rather than in cut-through crosswalk

This image shows a blind pedestrian walking on raised portion of the splitter island rather than in cut-through crosswalk area, disoriented as she walks parallel to traffic. An orientation and mobility specialist closely follows her.

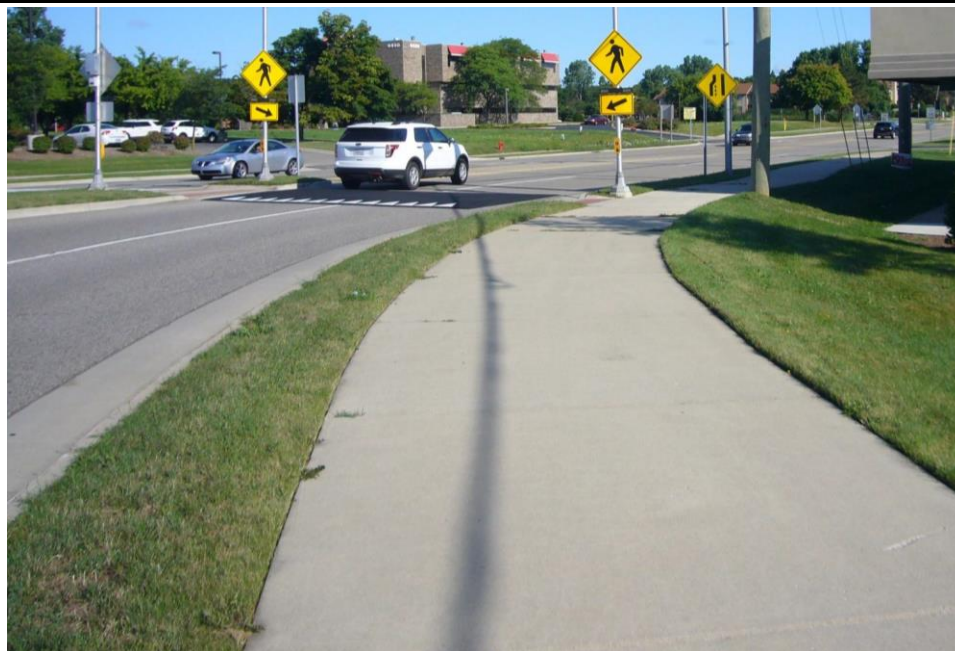
Figure 3-5: Detectable landscape separation at roundabouts

This figure shows a photo of a roundabout with adequate landscape separation between the sidewalk and the street. The separation is in the form of a 4-5 foot wide grass strip that follows the curvature of the road

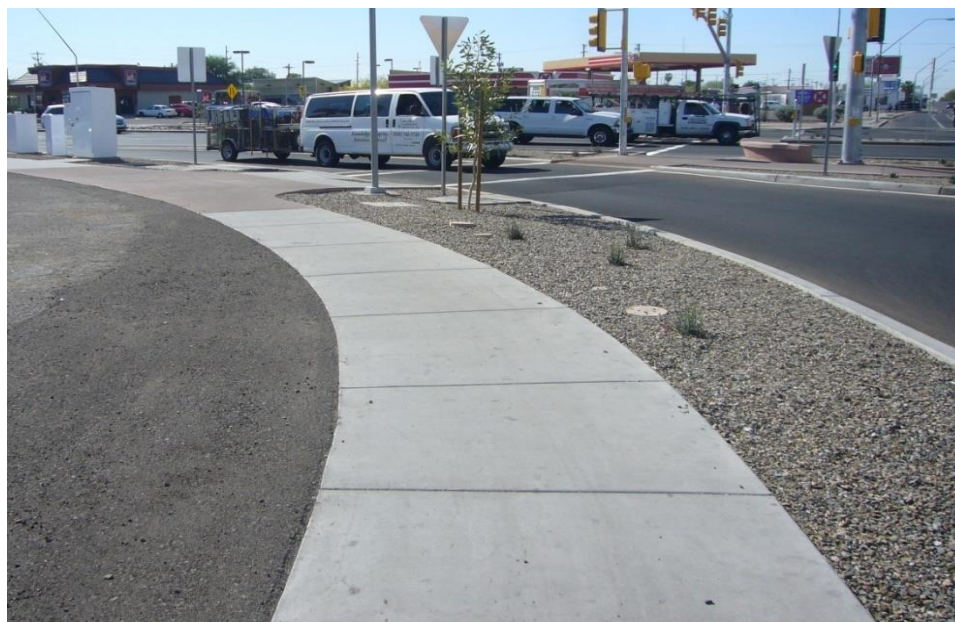
Figure 3-6: Detectable sidewalk separation at CTL using gravel surface

This figure shows a CTL with adequate landscape separation provided through a gravel surface.

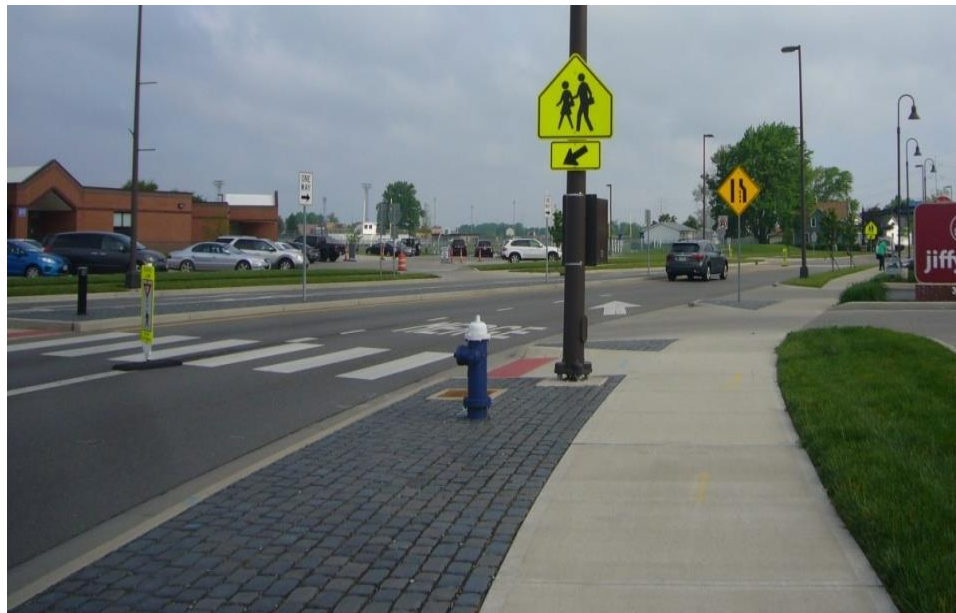
Figure 3-7: Sidewalk separation at roundabouts not detectable

This figure shows a roundabout with separation between sidewalk and road provided through paving stones, which are not detectable under foot or by use of a white cane.

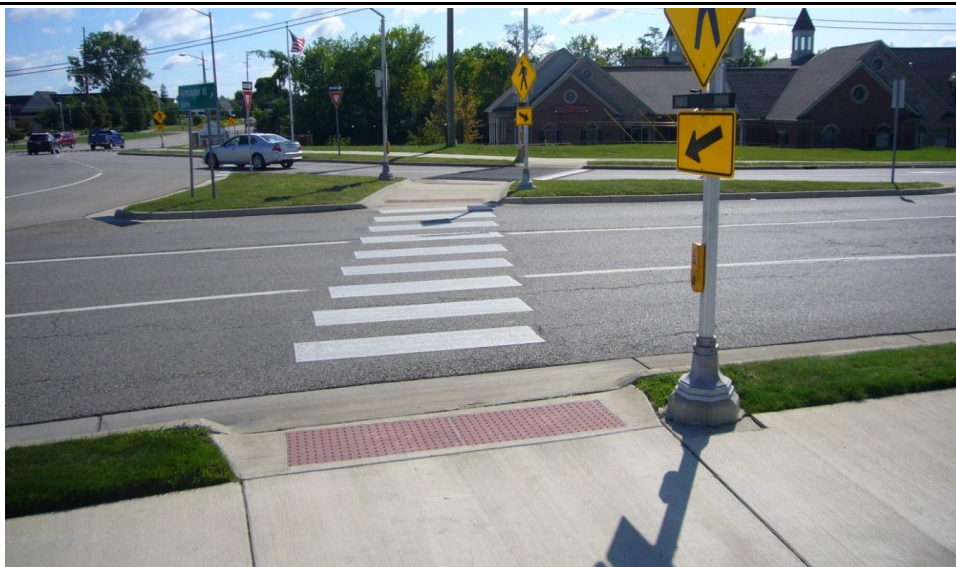
Figure 3-9: Roundabout crosswalk aligned too far to the left of island landing

This figure shows a photo of a roundabout with a crosswalk that is aligned too far to the left of the island for a wide three-lane crossing of a roundabout exit.

Figure 3-9 shows an example of a roundabout crosswalk aligned too far to the left of the crosswalk landing on the splitter island. Figure 3-10 shows an example of a blind pedestrian lining up to cross at a CTL.

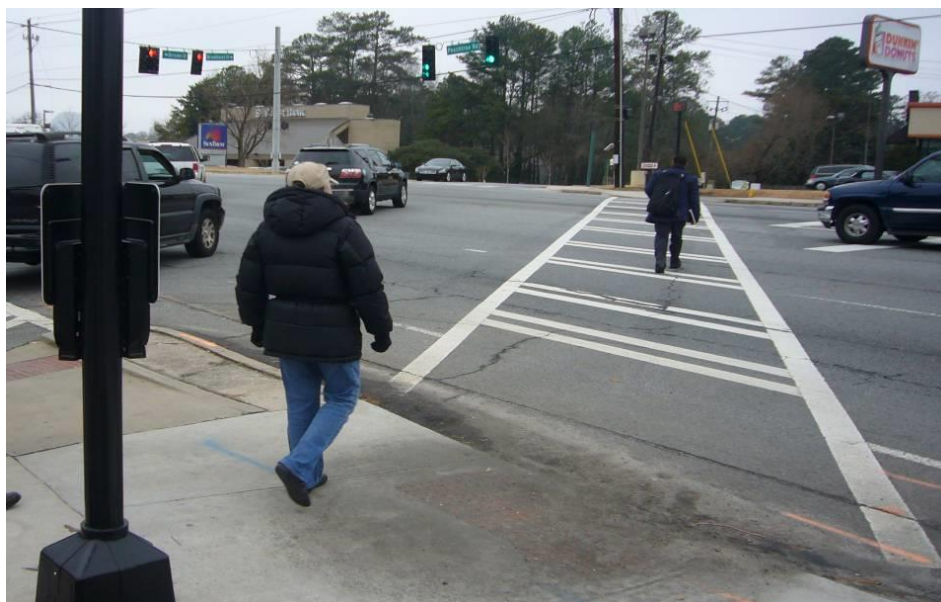
Figure 3-11: Blind Pedestrian Maintaining Crossing Heading at Signalized Intersection

The primary strategy used by pedestrians who are blind to maintain their heading and travel straight across crosswalks at signalized and stop controlled intersections is to travel parallel to straight-ahead traffic on the street beside them as they cross (Hill and Ponder, 1976, Jacobson, 2013,). Straying from the crosswalk is a common problem for blind pedestrians and typically results from initial misalignment (Guth, Hill, and Rieser, 1989;) or from veering from the initial alignment while crossing (Guth and LaDuke, 1994; Kallie, Schrater and Legge, 2007; 1955; Rouse and Worchel, 1955). This is illustrated in Figure 3-11.

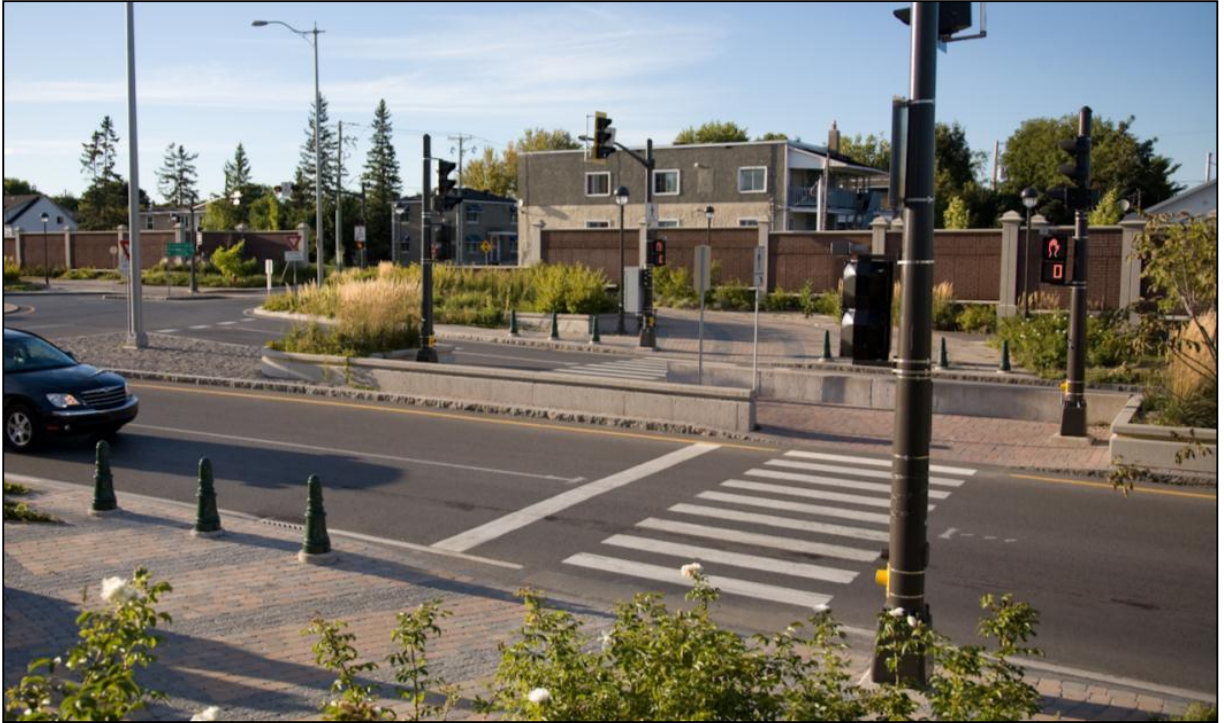
Figure 4-5: Staggered crosswalk with exit crosswalk further from roundabout in Canada, photo

Figure 4-5 shows an example of this crosswalk placement option at a roundabout in Gatineau, Quebec. This photo is provided only for the purpose of showing an existing staggered crosswalk at a roundabout. Some design details, such as different crosswalk widths and island opening widths and the use of bollards as a buffer, are not desirable from an accessibility standpoint.

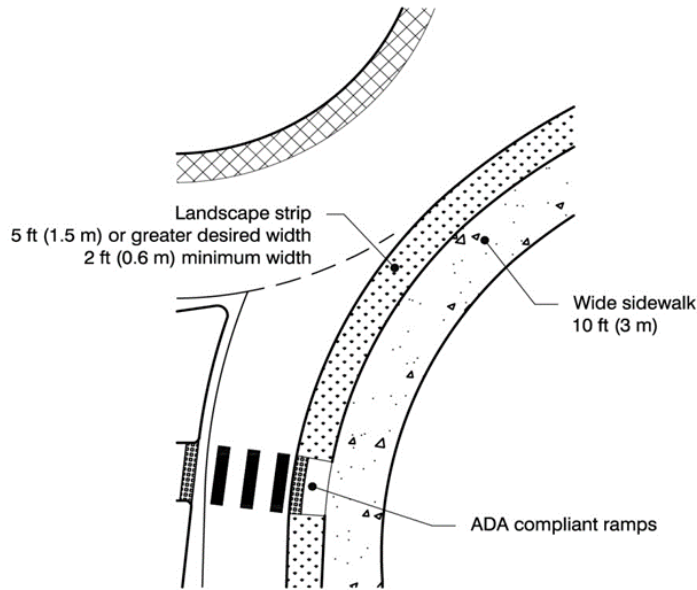
Figure 4-6: Roundabout with landscape buffer following roadway curvature

This figure shows a sidewalk that follows the curvature of the roadway in the roundabout, but is separate by an approximately 4 to 5-foot-wide landscaping buffer.

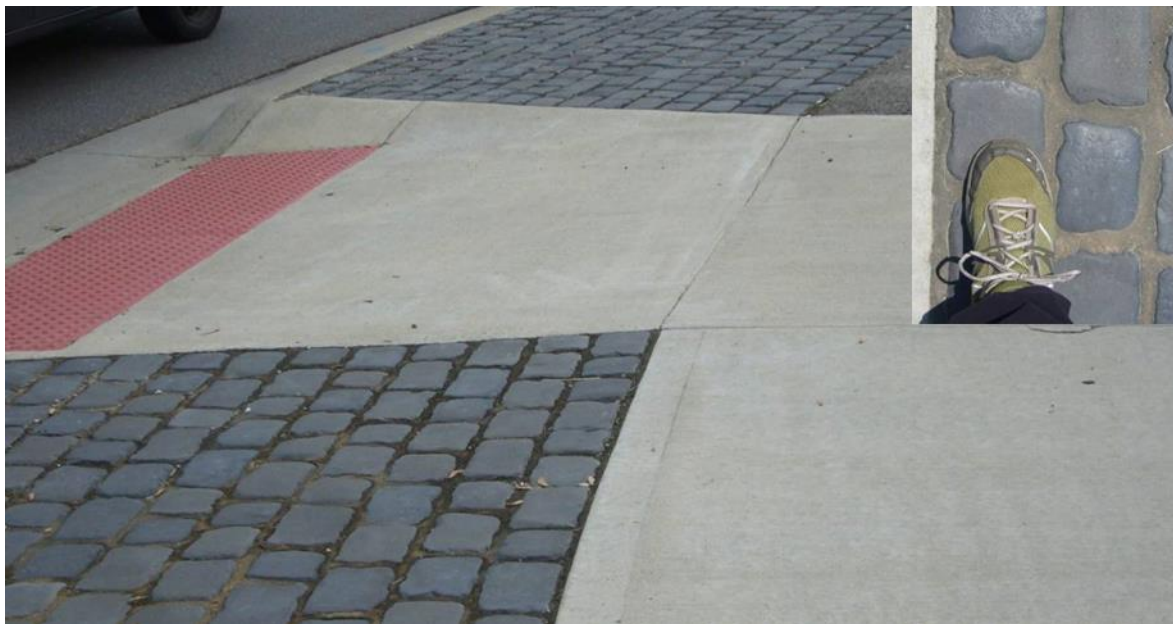
Figure 4-10: Example of surface material that was not recognized as a non-walking surface by blind participants

Pedestrians who are blind are unlikely to cross to the central island of a roundabout if there is a continuous grass or landscaping strip that is interrupted only by a curb ramp at a crosswalk. Such a landscaping strip could be gravel, grass, or some other surface that is detectable under foot. However, rough brick or a “cobblestone” type surface between the sidewalk and curb or on an island often was not recognized by participants in this research as a non-walking surface. Such a surface did not provide the desired cues to the crosswalk location or prevent crossing from the wrong location. An example is shown in Figure 4-10.

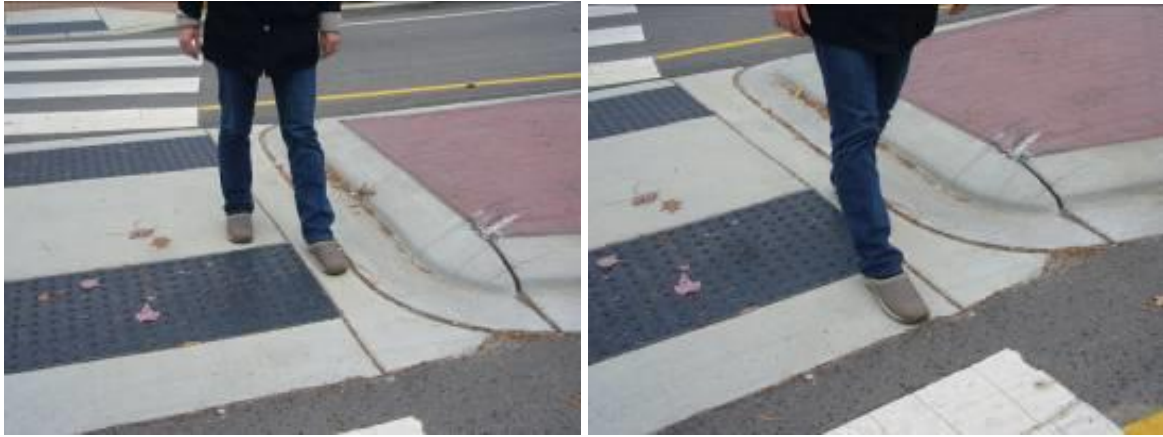
Figure 4-12: Example of Incorrect Detectable Warning Surface installation at a Roundabout crossing

The detectable warning surface must cover the entire curb ramp area that is level with the street in order to be reliably detected. As shown in Figure 4-12, a pedestrian can step past the detectable warning surfaces that do not extend across the entire width of the cut-through island and into the street without realizing it.

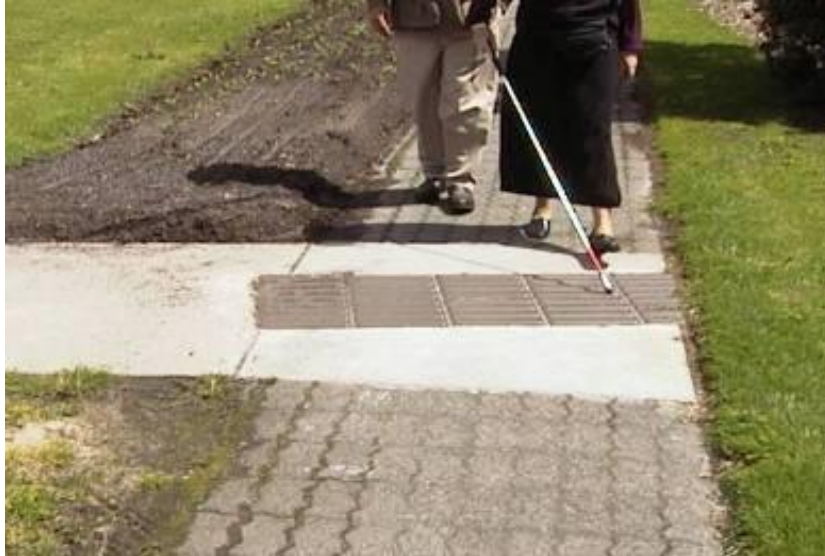
Figure 4-13: Australian bar tile surface example

PROWAG-NPRM states that “European and Australian roundabouts provide a 610 mm (24 inch) width of tactile surface treatment from the centerline of the curb ramp or blended transition across the full width of the sidewalk to provide an underfoot cue for identifying pedestrian street crossings.” (Advisory R306.3.1.). This tactile surface treatment referred to by the Access Board is a bar tile surface, or guidance tile, as shown in Figure 4-13, which is used in Australia.

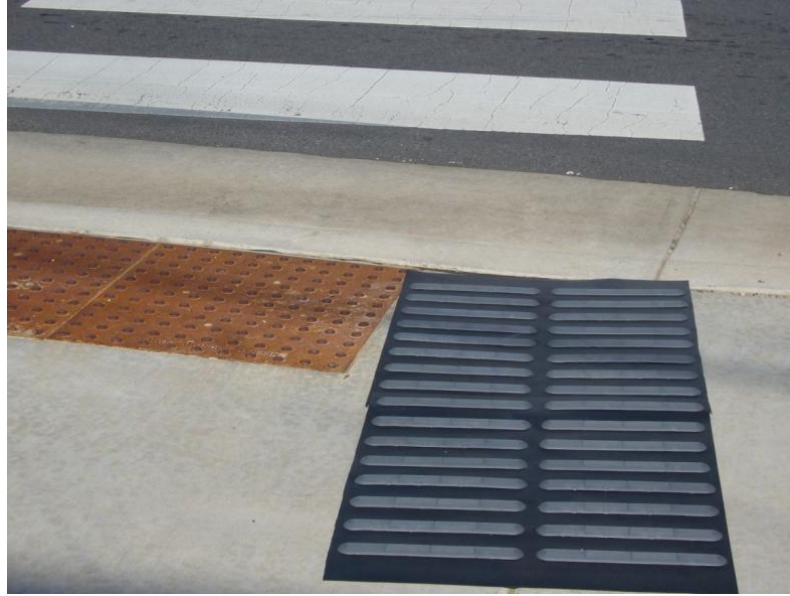
Figure 4-14: Photo of Experimental Bar Tile with bars perpendicular to the crosswalk direction.

A variation of the tile shown above, with bars perpendicular to the crosswalk direction is shown in Figure 4-14, as both an indication of the location of the crosswalk and to provide alignment information to blind pedestrians. It is noted that bar tiles are an optional treatment, and are not subject to the same requirements as detectable warnign surfaces.

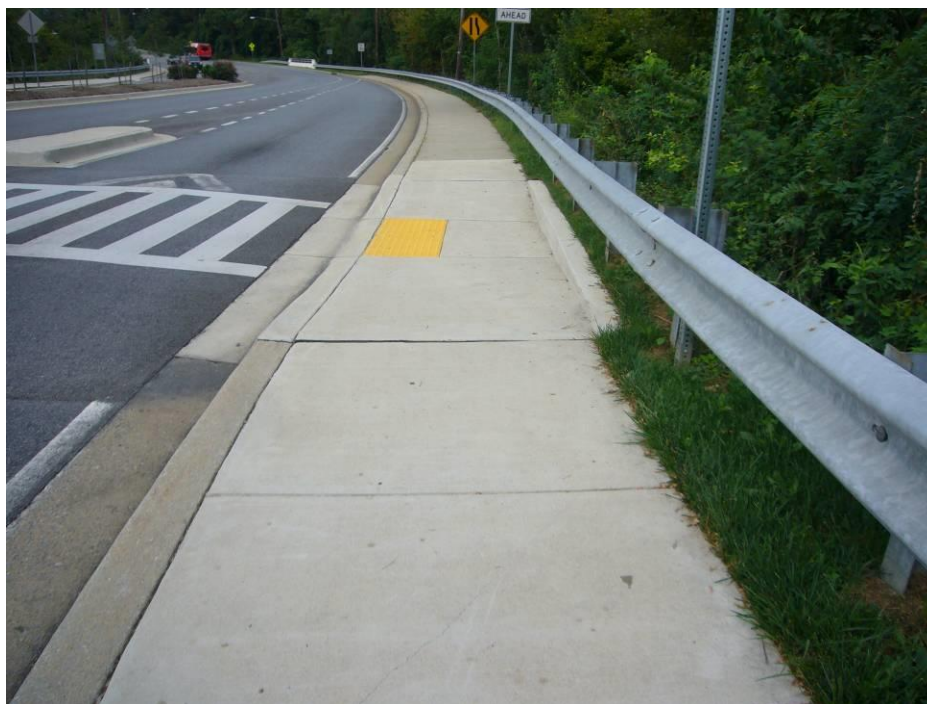
Figure 4-16: Image of Parallel Curb Ramp

An example of a parallel curb ramp is shown in Figure 4-16. Note the lack of landscape separation or fencing in the figure, which poses accessibility challenges.

Photo shows a parallel curb ramp at a roundabout crossing. A parallel ramp is often used when there is a narrow sidewalk at the back of curb. The entire sidewalk slopes down to a level landing at the crosswalk location. The detectable warning surface is installed along the curb line for the entire width of the level area. As noted in the text, there is no landscaping or barrier between the sidewalk and the curb, so a blind person is not guided to the crosswalk location.

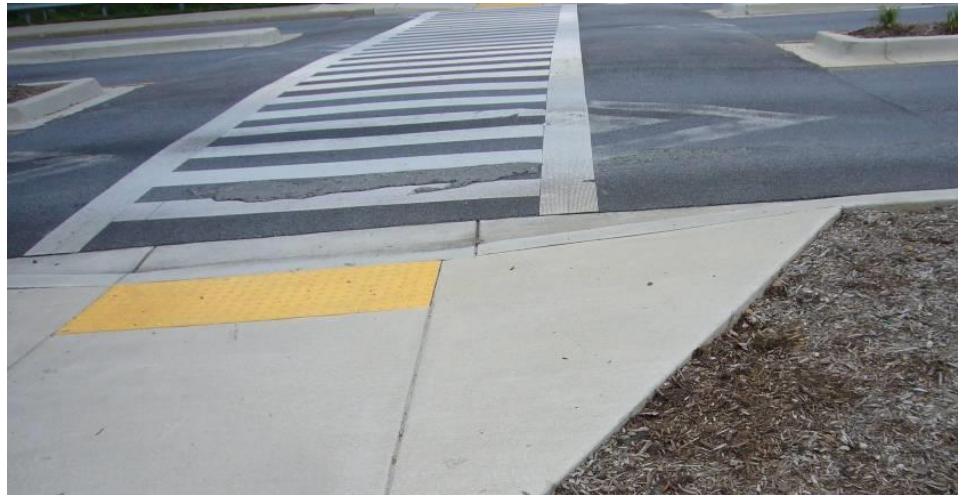
Figure 4-17: Image of Ladder Crosswalk Marking

For pedestrians with low vision, marked crosswalks can provide an useful cue to the crosswalk location and can assist with maintaining travel within the crosswalk. Pedestrians with low vision have stated a preference for ladder type crosswalk marking. Ladder marking have both transverse and longitudinal lines, making it easier for a person with low vision to follow a line across the crosswalk and still including the longitudinal lines that make the crosswalk more visible to drivers. Crosswalks that are brick colored may not be distinguishable from the asphalt street color for individuals those who are color blind, and are not as visible to drivers. An example of ladder-style crosswalk markings is shown in Figure 4-17.

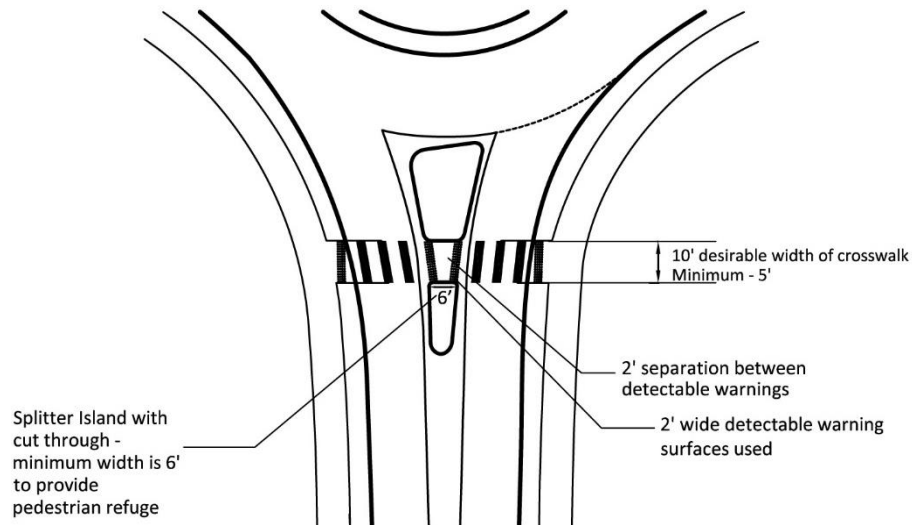
Figure 4-19: Minimum refuge island dimensions for cut-through island

Cut-through island need to be at least six-foot-wide in the direction of pedestrian travel to allow for a two-foot detectable warning at each road transition point, with a gap of at least two feet between sets of detectable warnings. The island opening also needs to be at least five feet wide in the direction of vehicle travel to allow two wheelchairs to pass one another [required by proposed PROWAG]. Ideally, the island opening should be as wide as the crosswalk. These dimensions are illustrated in Figure 4-19 for a cut-through island, and in Figure 4-20 for an island with ramps.

Figure on shows a six-foot minimum width of island with cut-through pedestrian path. Within cut-through area of the island for the full width of the cut-through is a 2-foot section of detectable warning surface, then 2 feet of smooth surface and another 2-foot section of detectable warning surface.

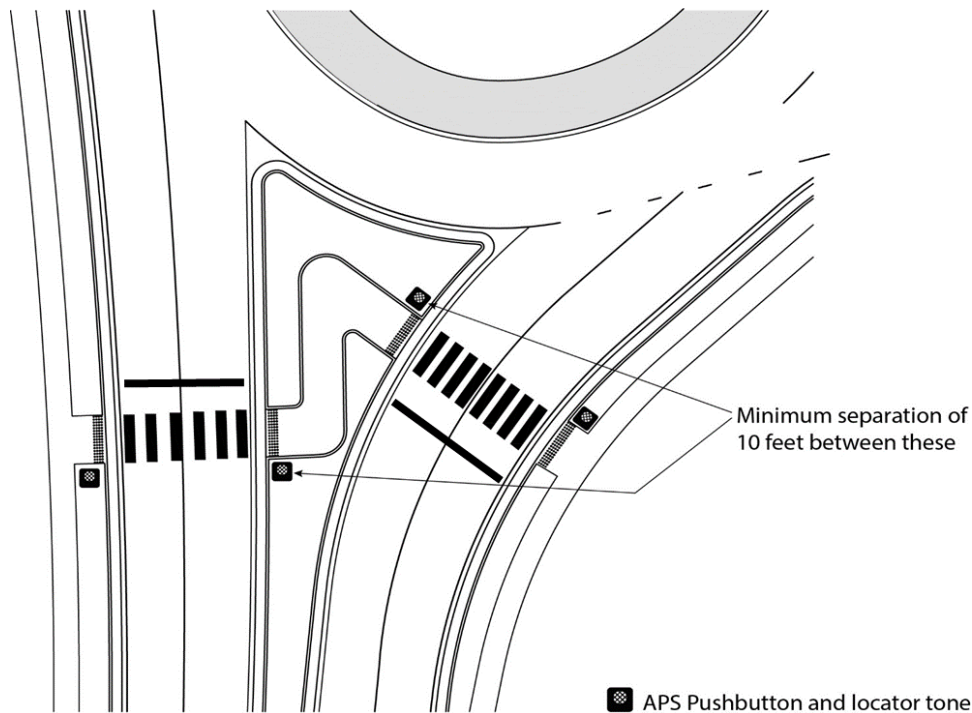
Figure 4-26: Location of Pedestrian Pushbuttons for Zig-Zag Crossing

If a crosswalk has a signal or beacon and APS or audible information devices are provided in the splitter island for a two-stage crossing, a wider splitter island is needed. The pushbuttons and audible messages must be separated by at least 10 feet, and poles must be set back from the curb by two feet to reduce the likelihood they are struck by vehicles and to properly locate pedestrian pushbuttons (see MUTCD sections 4D.16 and 4E.08 through 4E.10). Therefore, with a signal or beacon, and a straight pedestrian crossing, the minimum recommended width of the splitter island at the crosswalk location is 14 feet. Moving the exit portion of the crosswalk further away from the roundabout in a “zig-zag” island design can aid with providing adequate space for the required separation of entry and exit traffic control devices for pedestrians. The zig-zag may also allow for an island that is less than 14-feet wide, while still providing adequate separation, as illustrated in Figure 4-26.

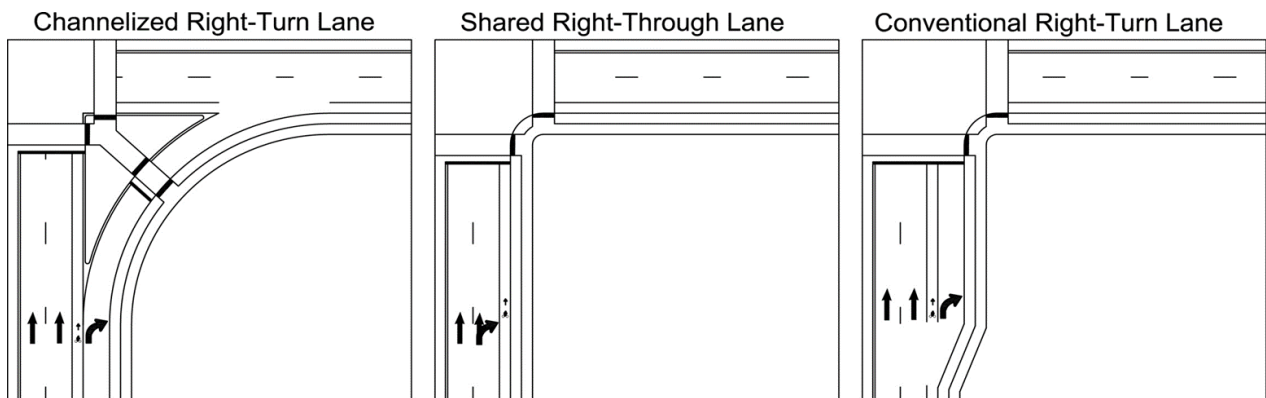
Figure 5-1: Types of Right Turn Lanes

Recent research (7) found that CTLs had lower motor vehicle crash frequency than conventional right turn lanes and higher motor vehicle crash frequency than shared right-through lanes. In other words, once a decision has been made that a designated right turn lane is needed for capacity, a CTL provides a safer configuration than an exclusive right turn lane without channelization. Figure 5-1 depicts these three types of right turn lanes.

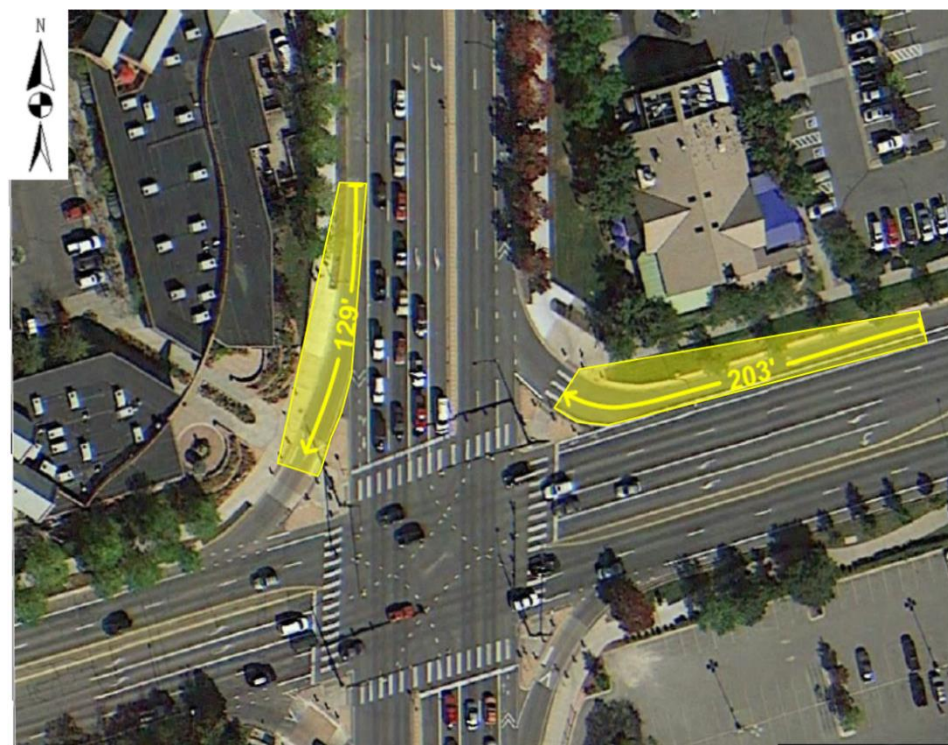
The figure shows an example application of the sight distance calculations a CTL. Sight distances are shown as arrows and the resulting sight "triangles" drawn relative from the respective waiting positions (on both curb and island) for a pedestrian to the end of the measured sight distance.

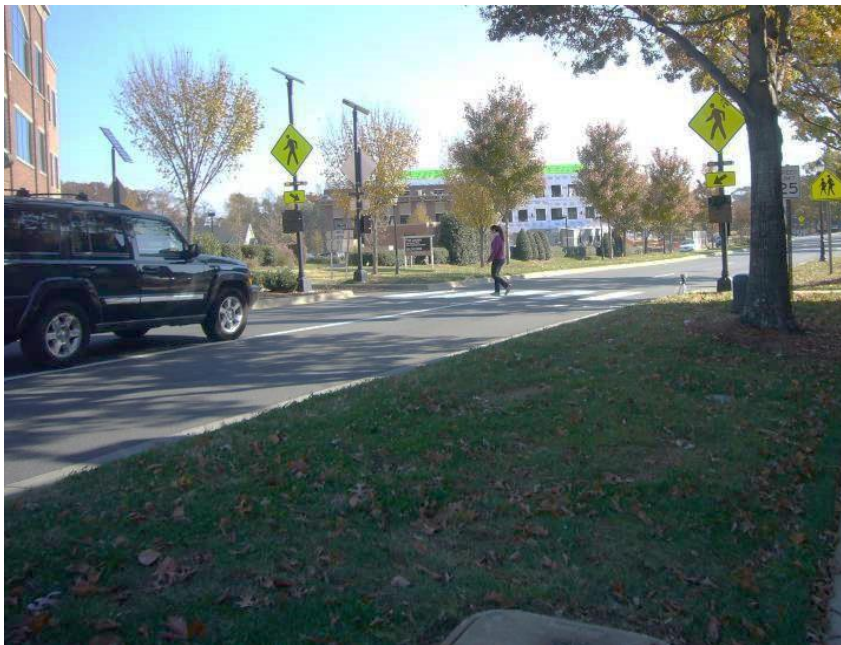
Figure 10-3: RRFB at Two-Lane Roundabout

This figure shows an RRFB at a two-lane roundabout.
